## Report Summary

Report Name: XYZ Data Center  
Completed for: XYZ Company  
Inspection Date: July 12, 2021  
Location: Anywhere, USA  
Contact: Bill Smith, Superintendent  
Score: 76.5%

**Scope of Work:** Test job to demonstrate new "Large Photo" template

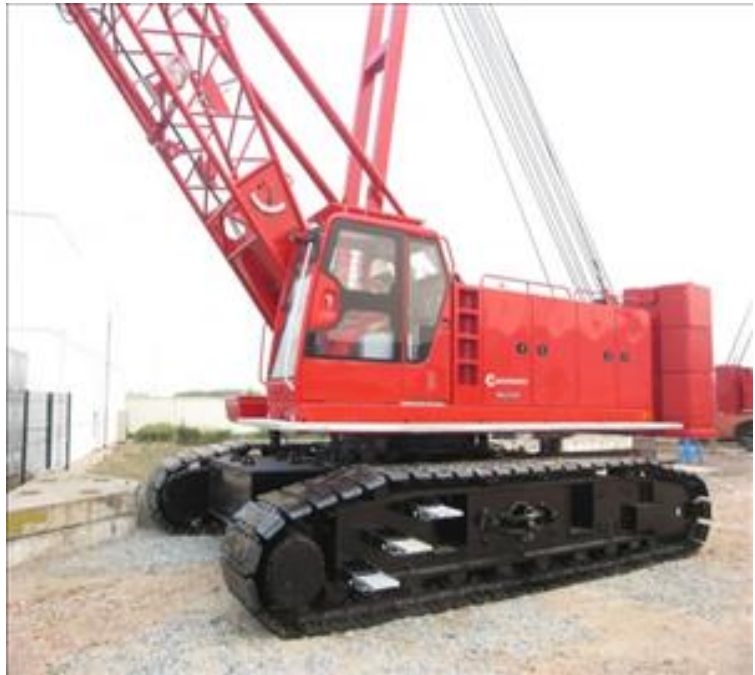
**Issue Identified:** Accessible areas within swing radius of crane are not barricaded to prevent workers from being struck or crushed (1926.1424) (See Photo)

**Notes:** Need to install radius guard on crane

**Severity:** Moderate 1

**Recommendation:** All accessible areas within the swing radius of a crane shall be barricaded to prevent workers from being struck or crushed. Take appropriate action to address issues of non-compliance. [reference 1926.1424(a)] [View OSHA Standard](#)

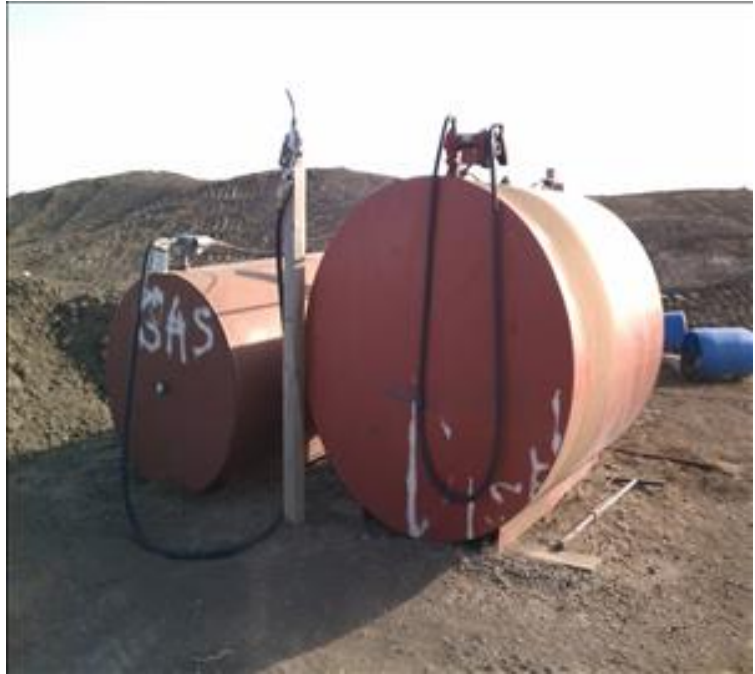
**Issue Identified:** Fuel tanks are not properly labeled/identified (NFPA 30) (**See Photo**)

**Notes:** Improper labeling on fuel tanks. Need to contact company that services the tanks.

No labels and no berm.

**Recommendation:** Take steps to ensure fuel tanks are properly labeled and/or identified with fuel name stenciled on tank, flammable placards, etc. per requirements in NFPA 30 and/or applicable local/state codes.

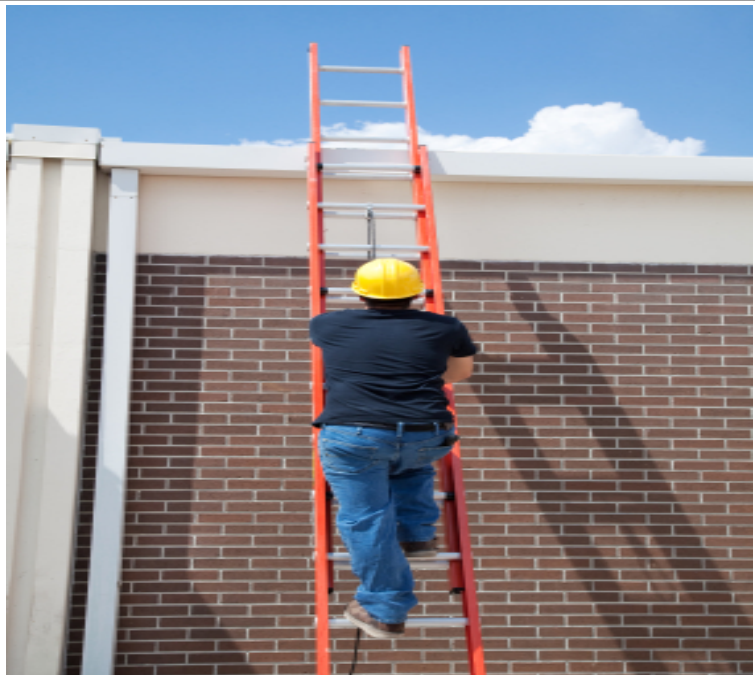
**Issue Identified:** Top of ladder/side rails are not secured as needed to prevent side shift (1926.1053) (**See Photo**)

**Notes:** This ladder was not secured. It was being used by multiple contractors to access the roof on the west side of building.

**Severity:** Serious Deducts 5%

**Recommendation:** Take appropriate steps to ensure ladder side rails are secured to a rigid support to prevent the top of ladder from shifting (i.e. slipping sideways and possibly falling over). [reference 1926.1053(b)(1)] [View OSHA Standard](#)

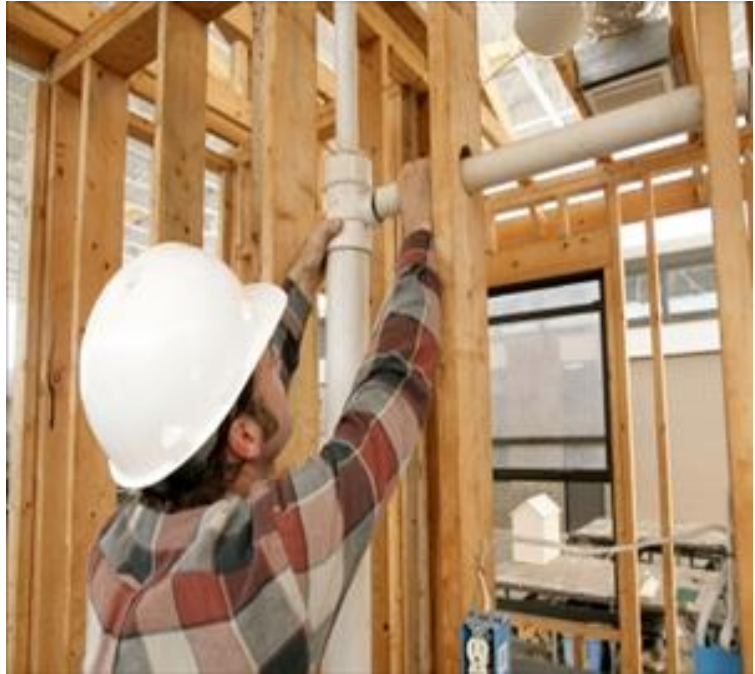
**Issue Identified:** Appropriate hand protection is not worn as required (1926.28) (**See Photo**)

**Notes:** Gloves are required when using adhesives to connect PVC pipes. No gloves were being used.

Need to use gloves when handling adhesives

**Recommendation:** Take steps to ensure employees use appropriate hand protection (i.e. leather, chemical resistant gloves, cut-resistant gloves, etc.) where hands are exposed to hazardous conditions. [reference 1926.28(a)]  
[View OSHA Standard](#)

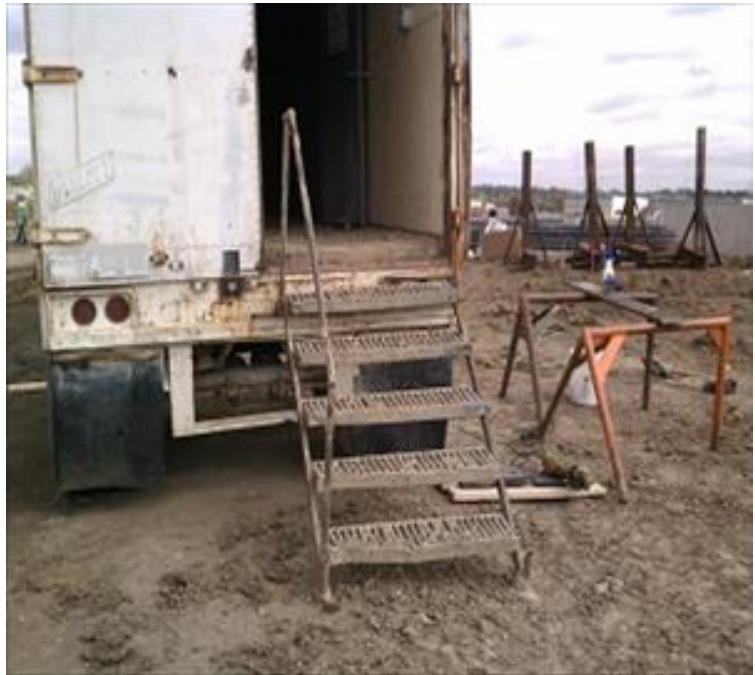
**Issue Identified:** An unsafe condition was identified that could potentially cause serious physical harm to employees if not corrected. See notes and/or photos for additional detail (5a1) (**See Photo**)

**Notes:** Stairs to storage trailer need to be repaired, add hand rail on right side.

These stairs need to be repaired or replaced!

**Recommendation:** Take steps to address the unsafe condition (or conditions) identified during the inspection that could potentially cause serious physical harm to employees if not corrected. [reference OSHA Section 5(a)(1)]  
[View OSHA Standard](#)

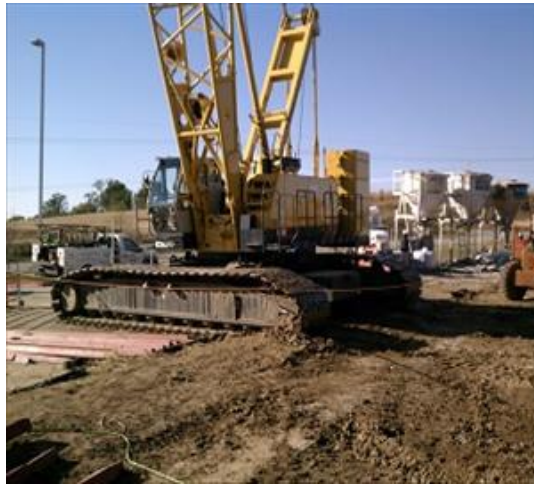
### Photo(s)

- Positive Finding** Required operational aides (i.e. boom angle/radius indicator, boom/jib hoist limiting device, anti two-blocking device, etc.) are installed and maintained (1926.1416)
- Positive Finding** Crane(s) and attachments are operated per manufacturer procedures (1926.1417)
- Positive Finding** A visual inspection by a competent person is completed each shift the equipment is used (1926.1412)
- Positive Finding** The rated capacities (load charts), instructions and operator's manual are kept in cab(1926.1417)
- Positive Finding** Accessible areas within swing radius of crane are barricaded to prevent workers from being struck or crushed (1926.1424)

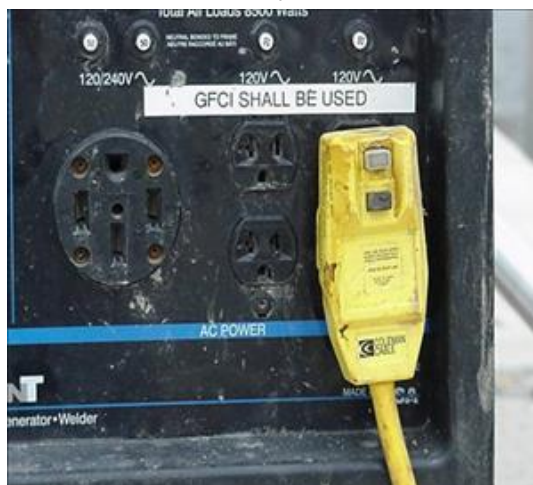
### Photo(s)

- Positive Finding** Ground pins are attached to electrical cords (i.e. extension cords and/or flexible cord sets) (1926.404)
- Positive Finding** GFCI is used for temporary power connections (1926.404)

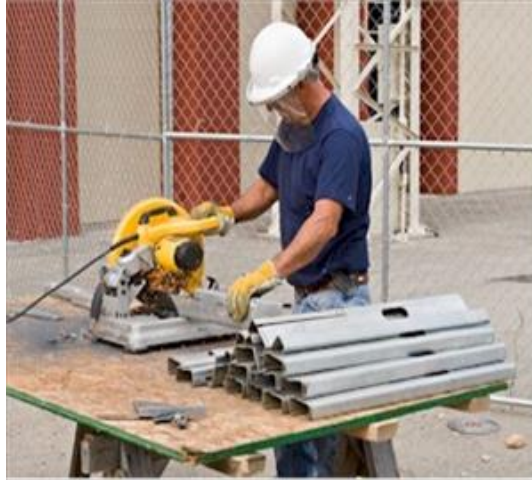
- Positive Finding** PPE maintained in a sanitary/reliable condition (1926.95)
  - Positive Finding** ANSI approved eye protection is used as required (1926.102)
  - Positive Finding** Face protection is used when sawing, cutting, grinding, welding, etc. (1926.102)
- Photo(s)**

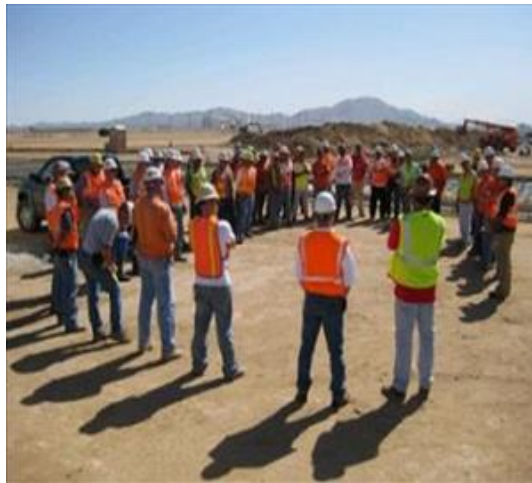
- Positive Finding** Toolbox talks are completed weekly per company policy (1926.21)
- Photo(s)**
